Schedule B Municipal Class Environmental Assessment Study Fletcher's Creek Slope Stabilization

Prepared for
Regional Municipality of Peel

CH2M HILL Canada Limited
245 Consumers Road
Toronto, Ontario M2J 1R3

December 2013

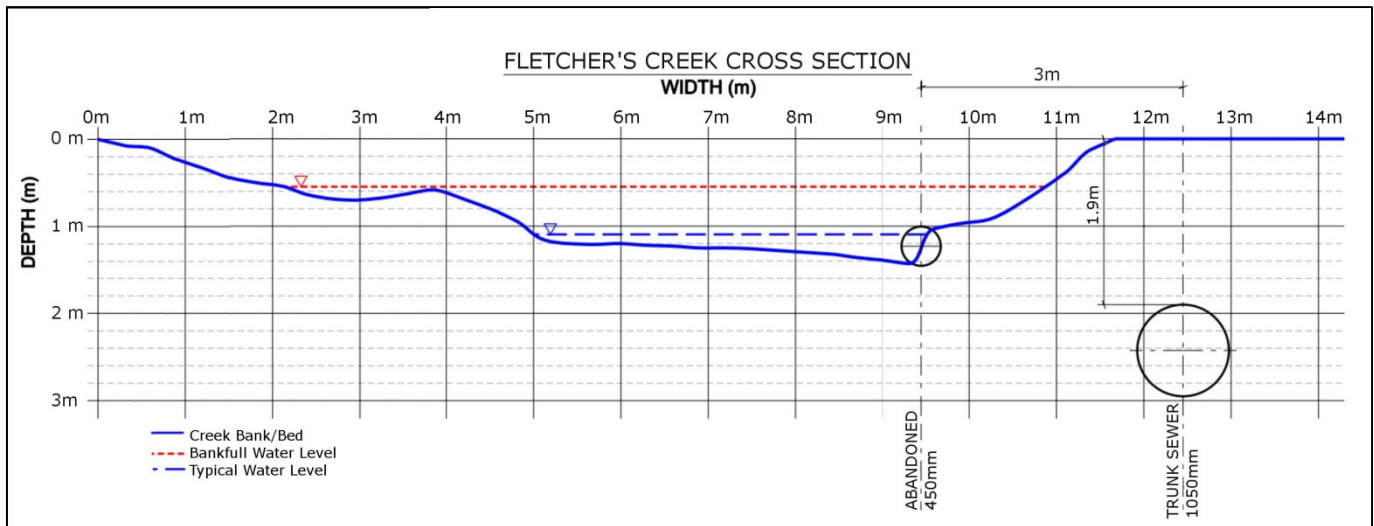
Figure 2-1: Location of exposed, abandoned sewer pipe and active trunk sewer pipe in the vicinity of Fletcher’s Creek, approximately 75m upstream of Denison Avenue

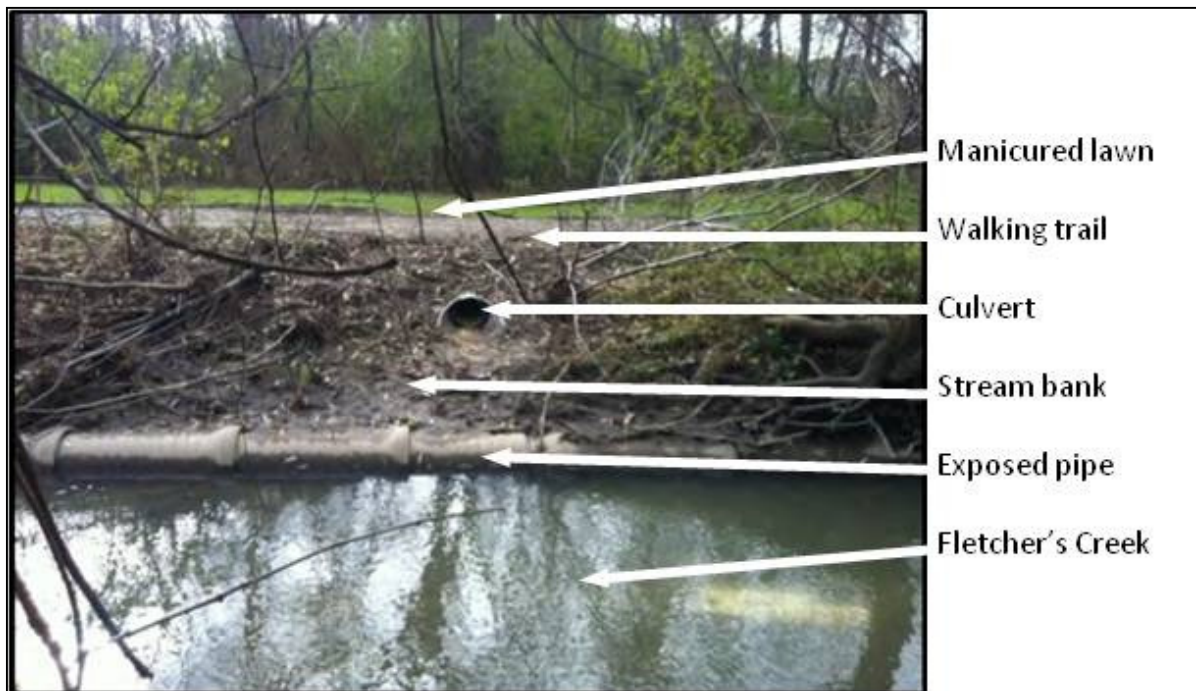
Although the abandoned pipe may be providing some stability at the toe of the slope, the main concern of the Region is that further erosion from overland flow and high stream flows during wet weather events, and natural erosion processes within the creek will result in damage to or breakage of the active trunk sewer.

Figure 3- 1: Photograph of exposed pipe in Fletcher's Creek, upstream of Denison Avenue, November, 2012
