Contamination Overview Study

Arterial Roads Within Highway 427 Industrial Secondary Plan
Area (Area 47) – Environmental Assessment Study
Brampton, Ontario
Project No. TP115086

September 2020

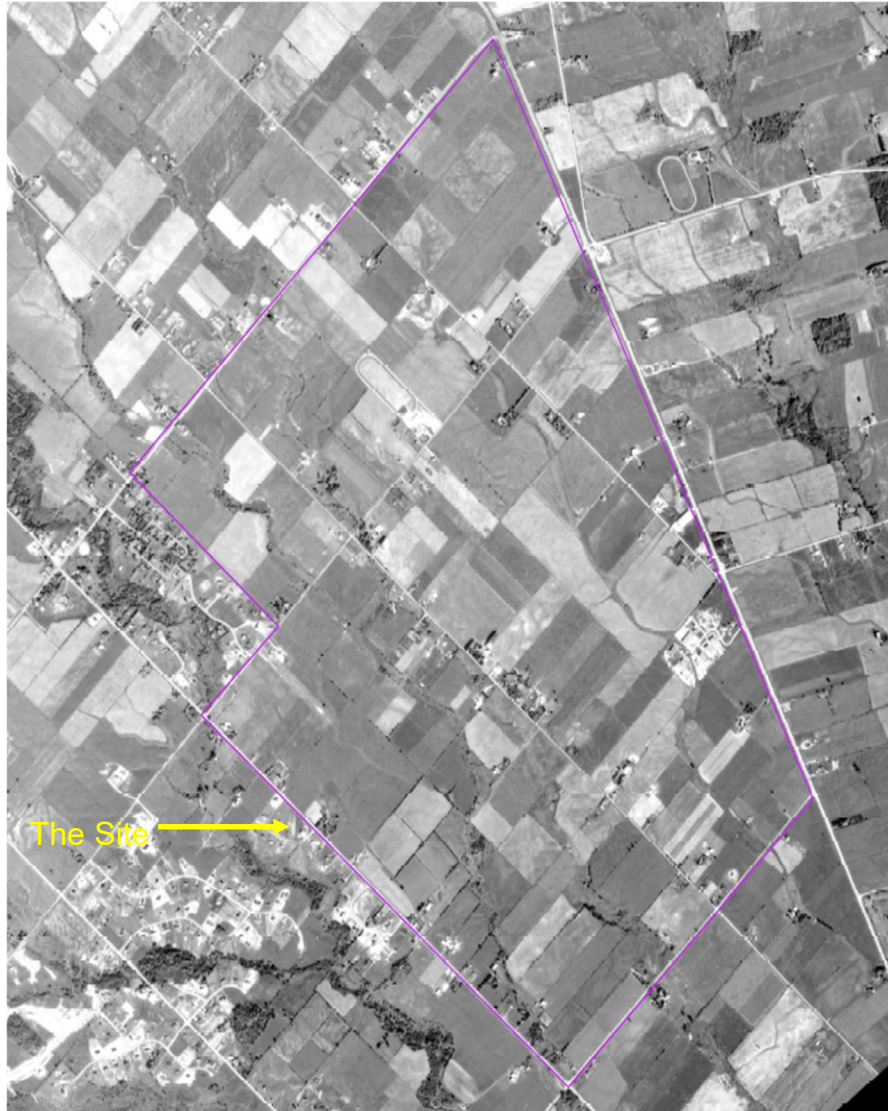
Aerial Photograph

1988 1: 40,290	Seven (7) rectangular buildings, likely of commercial or industrial use, are visible in the eastern portion of the Site, from Highway 50. Additional residential properties are present on Clarkway Drive.	<p>A residential subdivision is visible west of the Site, and north of Countryside Drive.</p> <p>No other major changes were noted in the Study Area.</p>
2004 Scale Unknown	<p>The area of commercial and/or industrial use from Highway 50 has expanded. Equipment and tractor trailers are visible around the buildings.</p> <p>An additional commercial and/or industrial property is present in between Coleraine Drive and Highway 50.</p> <p>The rest of the Site is still generally comprised of residential and agricultural properties.</p>	<p>Additional residential subdivisions are visible west of the Gore Road.</p> <p>Commercial warehouses are visible east of the Site, on the east side of Highway 50.</p>

Date: May 2020	Scale: 1:40290	Project No.: TP115086
1988			Drawn by: SD	Approved by: IP

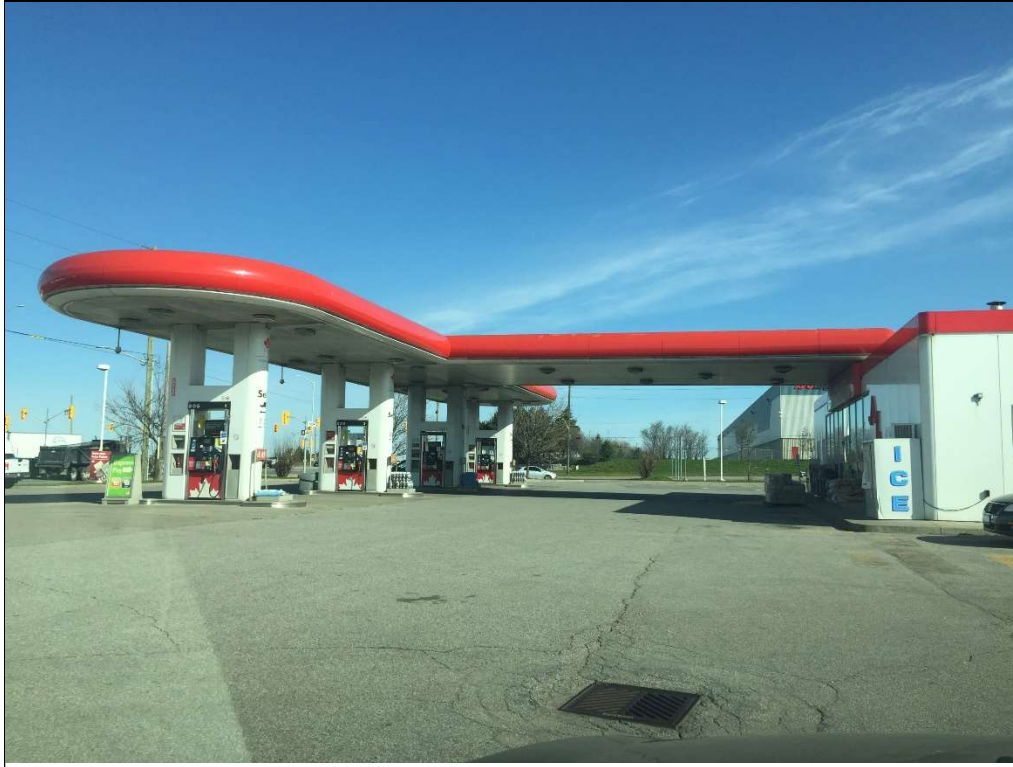
Photo 1:
Gas station located at the southeast corner of Regional Road 50 and Rutherford Road.

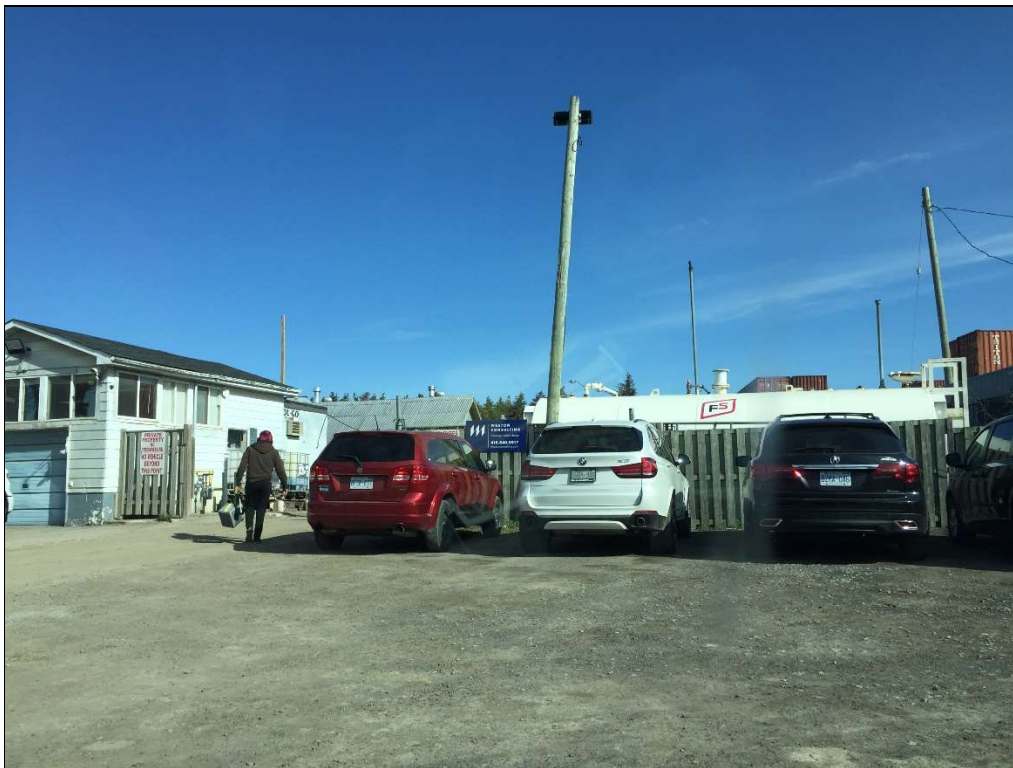
Photo 2:
View of the aboveground storage tank (AST) at the northeast corner of Regional Road 50 and Major Mackenzie Drive.

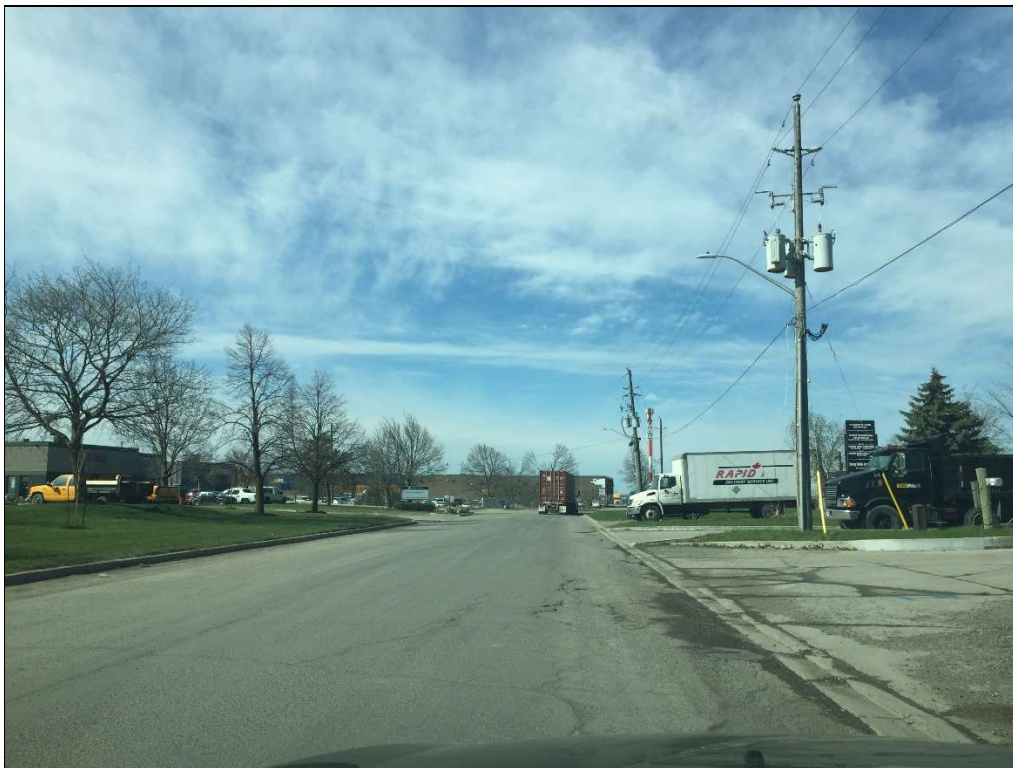
Photo 4:
General view of
properties on
Cadetta Road.

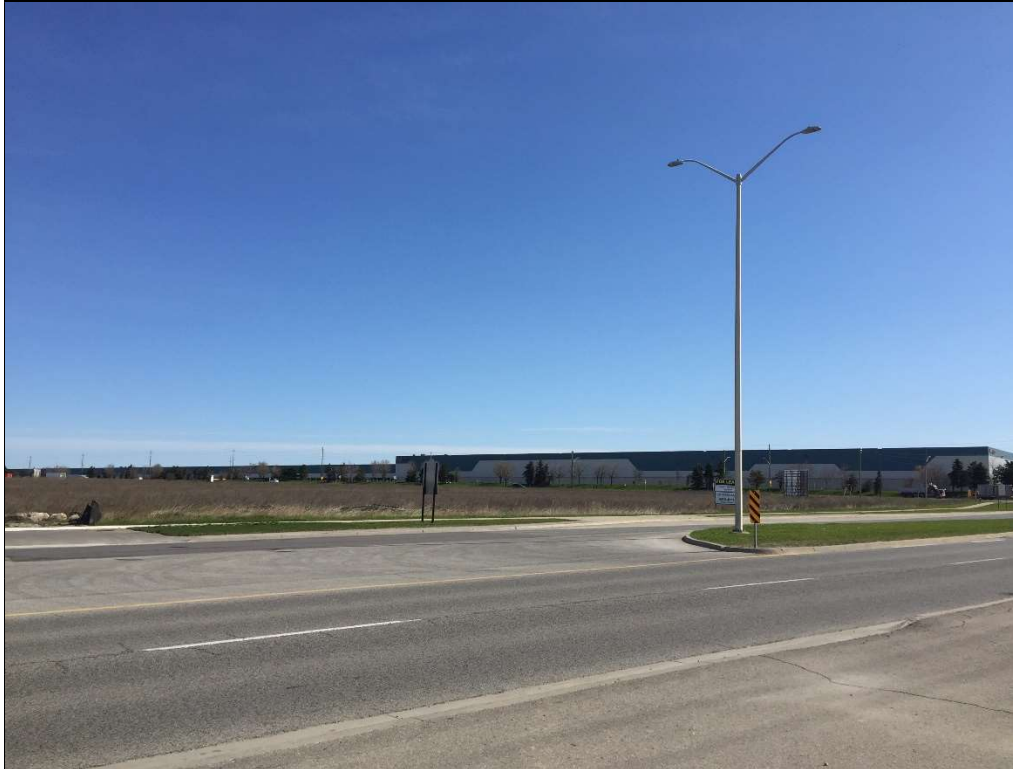
Photo 5:
View of agricultural land and warehouses at the corner of Old Castlemore Road and Regional Road 50.

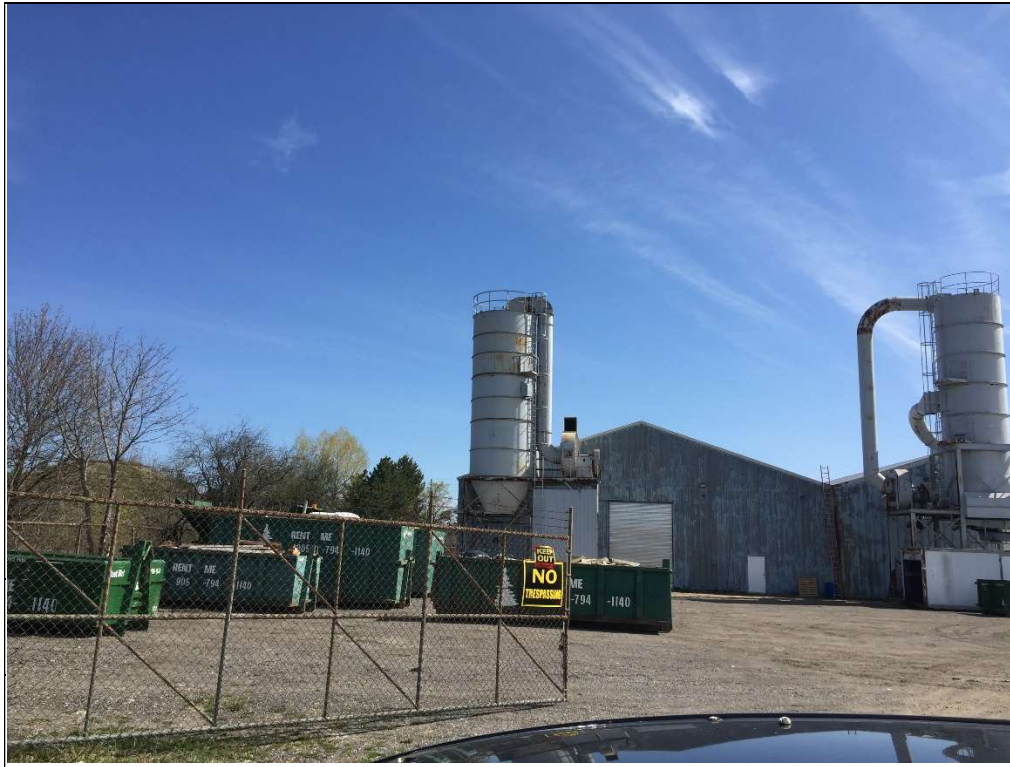
Photo 7:
View of the industrial property at 10562 Regional Road 50.

13	10562 Highway 50	Industrial building, with soil fill piles noted on the property.	Industrial property use 30. Importation of fill material of unknown quantity	All COCs listed at the end of this table
14	North end of Old Castlemore Road	Fill pile with concrete and brick material dumped at the end of Old Castlemore Road	30. Importation of fill material of unknown quantity	All COCs listed at the end of this table
15	20 Cadetta Road	Quality Fabricating – Listed as a iron and steel mill and ferro-alloy manufacturer, and miscellaneous fabricated metals products manufacturing.	34. Metal Fabrication	Metals VOCs PHCs

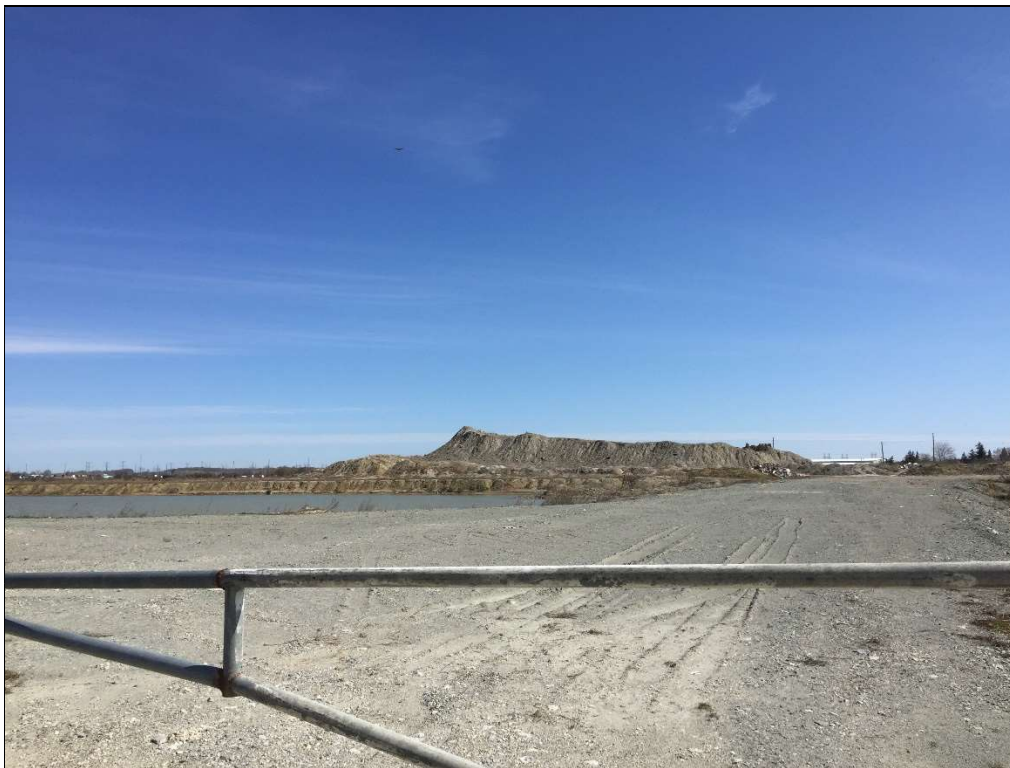
Photo 8:
View of soil piles on Coleraine Drive.

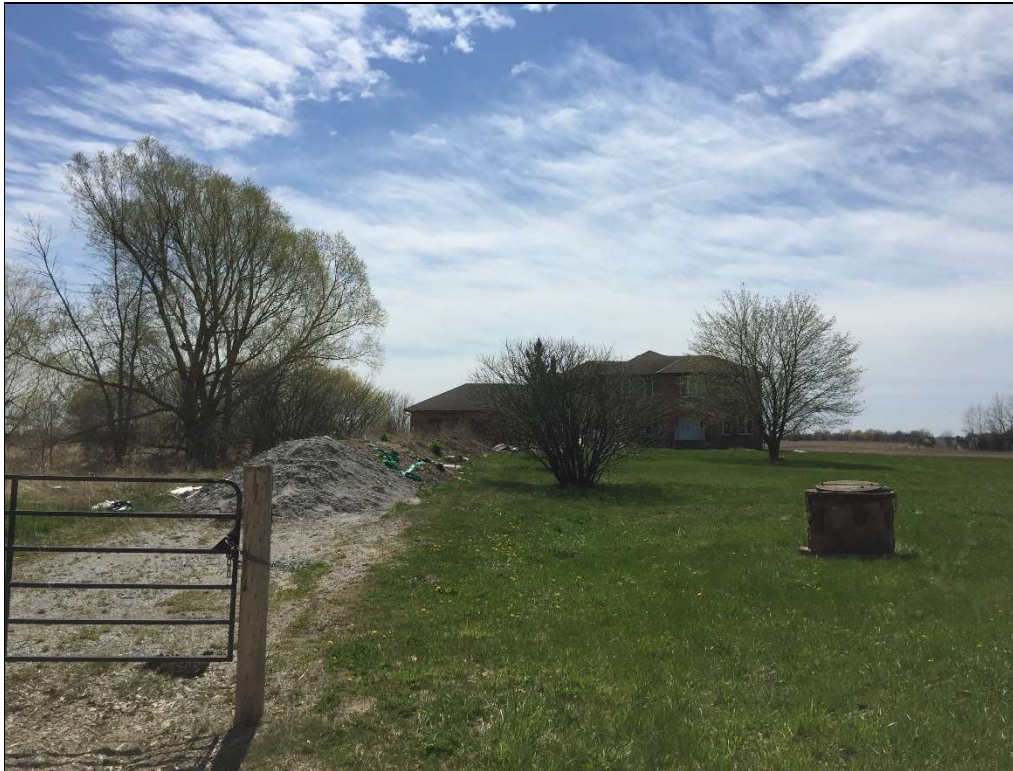
Photo 11:
View of soil fill piles
in front of 5253
Countryside Drive.
